Fires and BLEVE on LPG tanker lorries

27 July 2010

Port-la-Nouvelle (Aude)

Explosion / BLEVE
Transport of hazardous
materials
Projections
Propane
Mobile storages

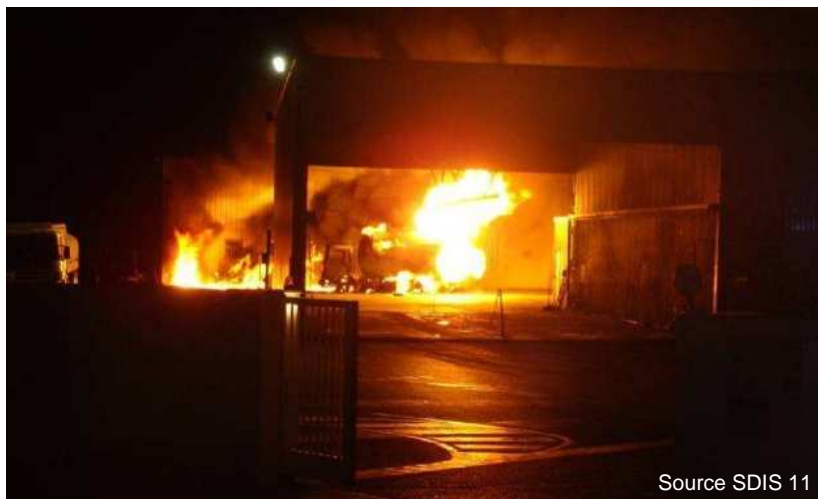
Photograph of a fire-fighter arriving at the scene of the accident

In attempting to cool the cistern while remaining 100 m away, due to the inherent BLEVE risk, responders heard a whistling noise at 12:16 am and retreated to safety just before the BLEVE explosion of the tanker lorry and the ensuing "fireball" observed by eyewitnesses.
